## PROPERTY INSPECTION REPORT

**Prepared For:** Andy  
 (Name of Client)

**Concerning:** 13706 in the community of Sycamore Valley  
 (Address or Other Identification of Inspected Property)

**By:** Michael Cothran, TREC License # 2995 2/13/2009  
 (Name and License Number of Inspector) (Date)

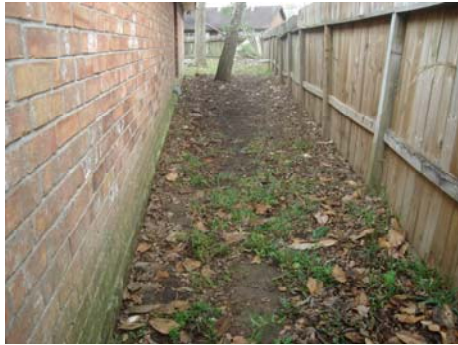
R - The grading should be improved to promote the flow of storm water away from the house and off the lot. The ground should slope away from the house at a rate of one inch per foot for at least the first ten feet. Ideally, at least eight (8) inches of clearance should be maintained between soil level and the top of the foundation walls. See comments/recommendations under foundations.

Trenching, against the foundation, is not acceptable.

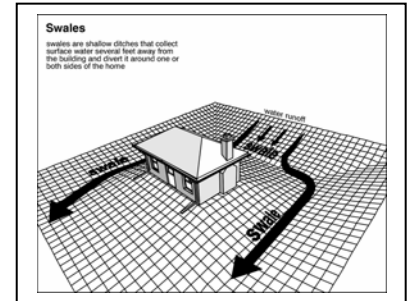
The target for slab exposure is 8 inches in sided areas and 6 inches in bricked veneer areas.

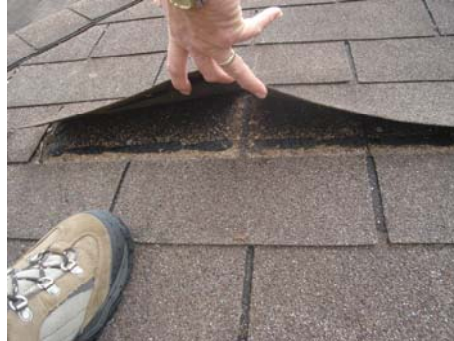
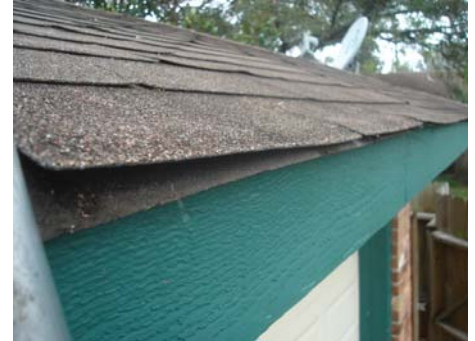
R – Shingles have adhesive on the bottom of each shingle which “glues” it to the adjoining shingle. In this way the individual shingles become a unified roof covering. This is as important as the fastening of the shingles. On this home several areas were noticeable that adhesion has not taken place.

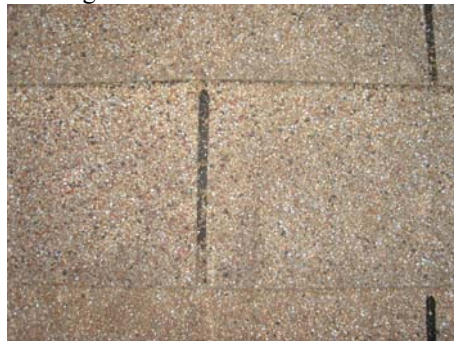
R – Approximately 30% of the protective ceramic granules are missing from the shingles.

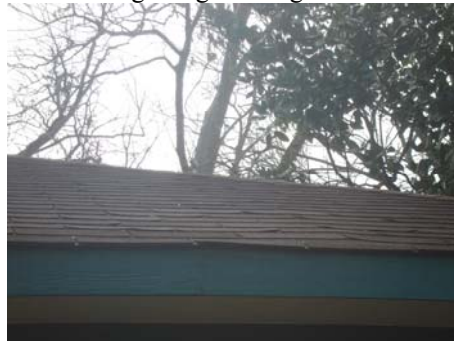
R – Shingle edge curling was observed in several locations.

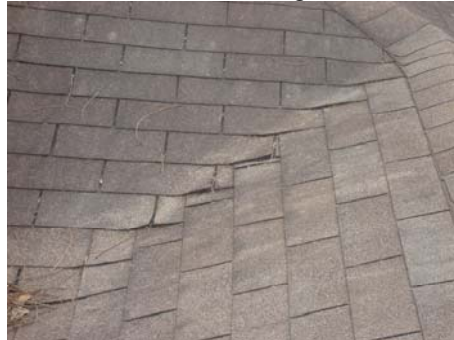
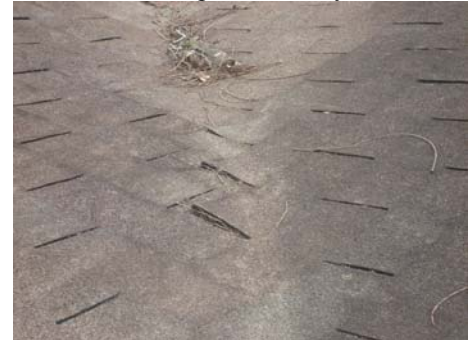
R - The shingle valleys are cut incorrectly. The largest drainage span should overlay the smaller. Debris should be removed from the roofing. It allows premature deterioration of the shingles and damming of rain water with possible entry into attic.

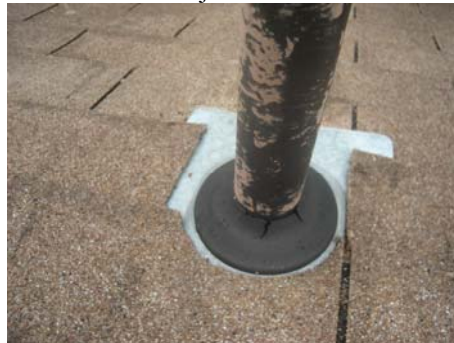
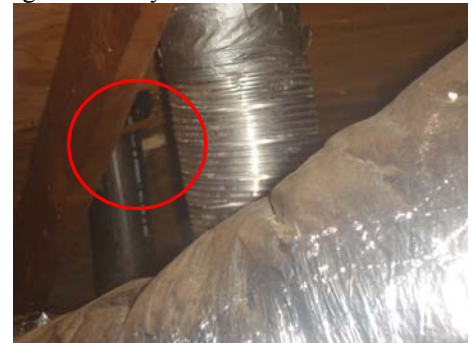
R – Some roof jacks are cracked and allowing water entry.

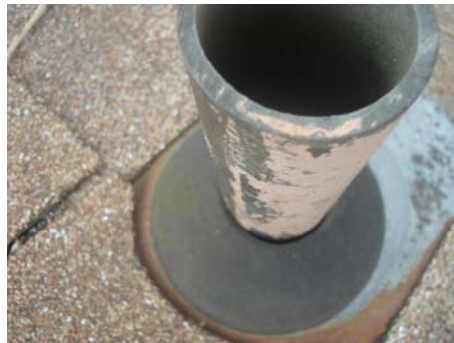
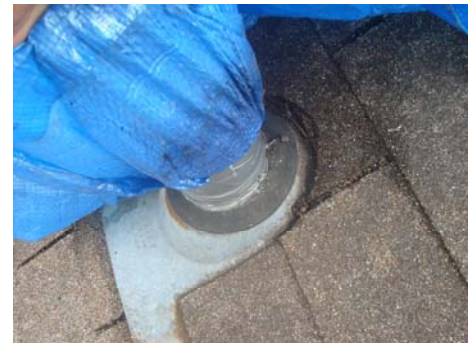
R – Some roof jacks are oversized and allowing water entry – the one near the furnace has allowed sufficient water entry to deteriorate the plywood substrate – this should be anticipated in other plumbing jack areas – the attic was only inspected from the furnace area due to headroom.

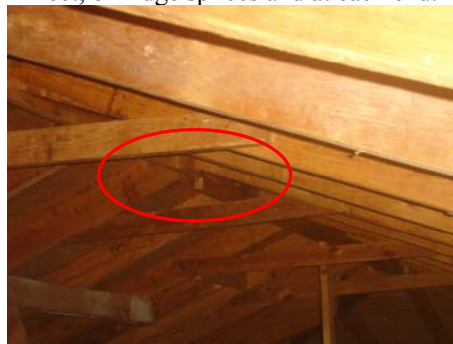
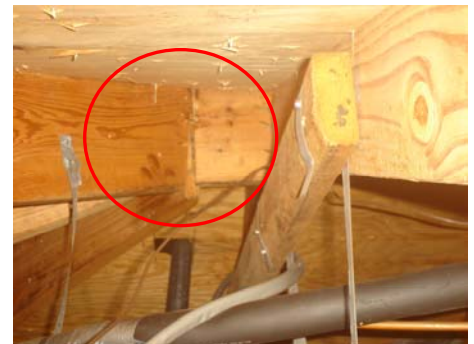
R - The ridge bracing is inadequate. Ridge bracing should be placed about every 12 feet, on ridge splices and at each end.

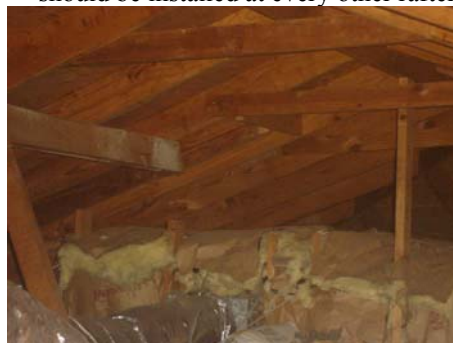
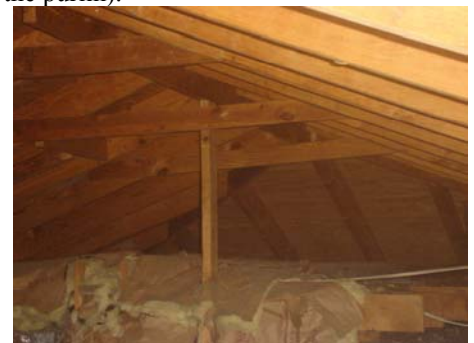
R – The rafter bracing is inadequate. Rafter braces are called purlins. Purlins should be placed about 2/3's the distance between the wall and the ridge. Purlins bracing should be installed at every other rafter (at the purlin).

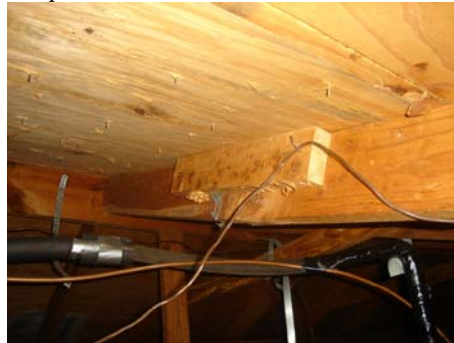
R - The hip bracing is inadequate. Hip bracing should be placed in the center and on splices.

Bracing should be installed directly under the framing member to be supported and terminated on load bearing walls.

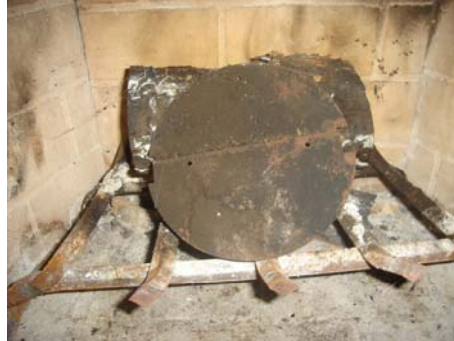
R – The damper has fallen off and should be repaired.

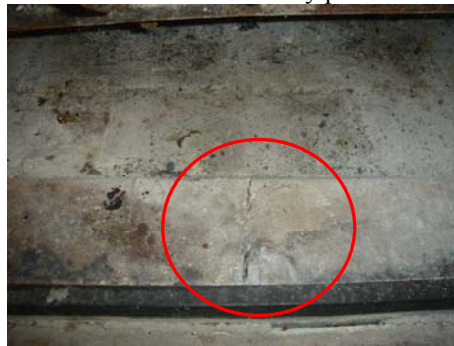
R – The bottom refractory panel in the firebox is cracked.

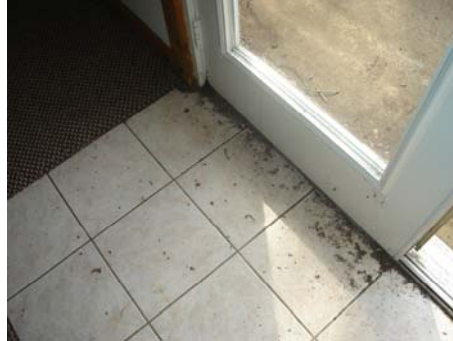
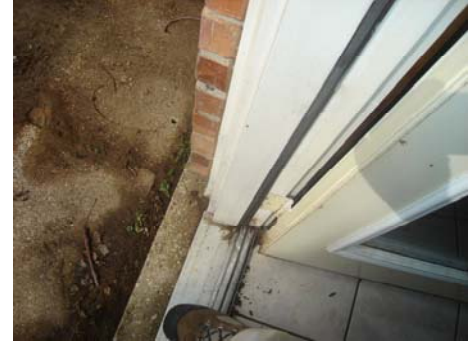
- Water is entering under patio door, adjoining stud damage should be anticipated.

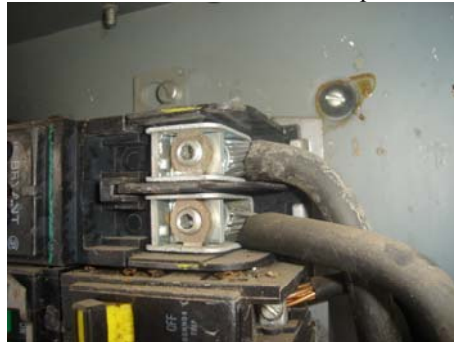
R – The connections (lugs) for the aluminum wiring, appear to be aluminum rated but lack antioxidant cream which prevents patina buildup. IRC 3306.8

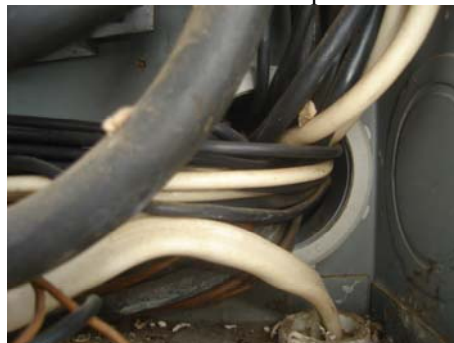
R – The conduit from the breaker box thru the wall to the dry side of the wall, is not installed – this is done to protect the wiring from damage and water.

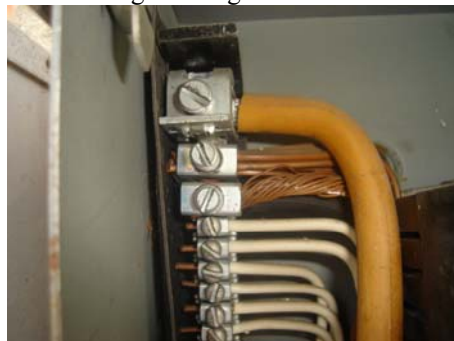
R – The grounding wires should be in separate connectors at the bus bar.

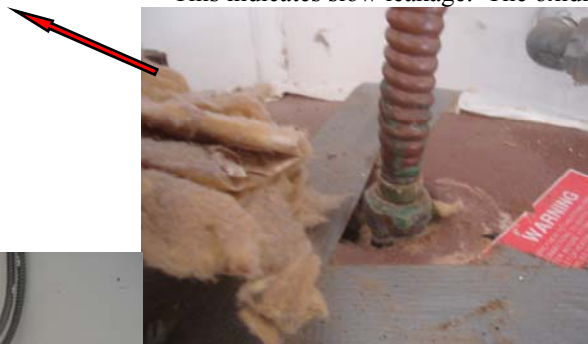
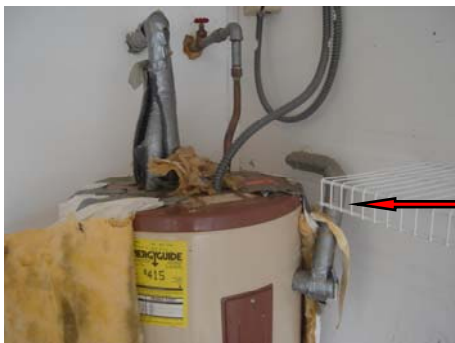
R - The supply piping shows evidence of corrosion where it meets the water heater. This indicates slow leakage. The oxidized unions should be replaced. Cold feed.

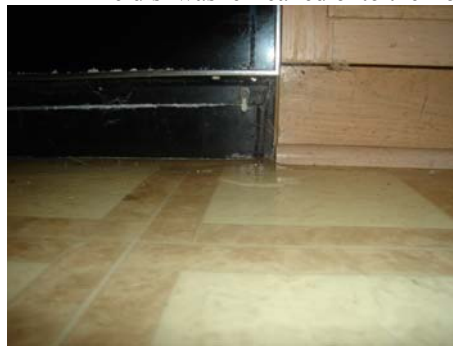
R - The dishwasher leaked onto the floor very soon after engaging.
