PROPERTY INSPECTION REPORT

Concerning: 12122

By: Michael Cothran, TREC License # 2995

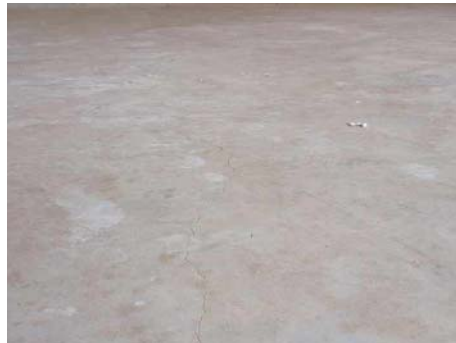
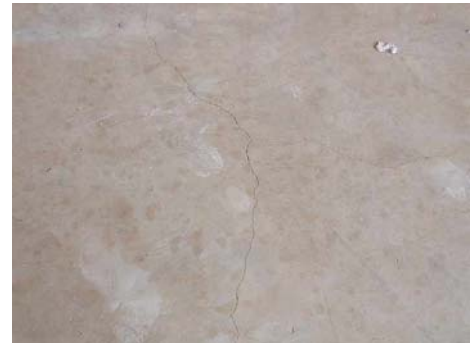
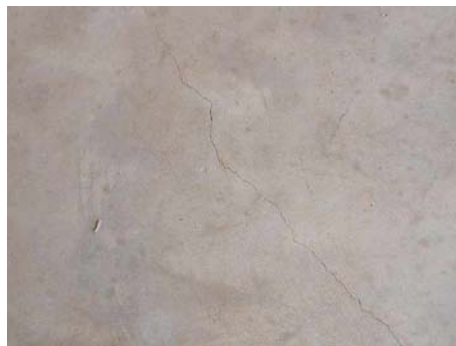
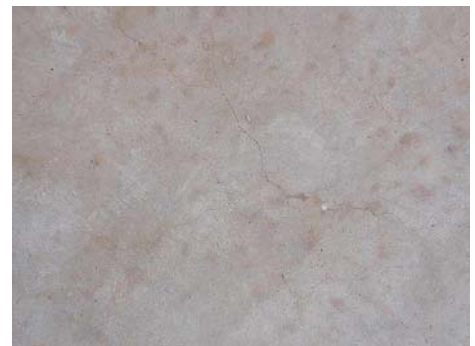
The survey of the visible perimeter beams and uncovered floors revealed cracks in the garage floor;

- Two of these cracks were gapped and did appear deflected.
- One, nearest to the front wall, was closed and did not appear deflected. As with all slabs (cracked or not) this situation should be monitored periodically.
- These cracks are all roughly parallel to the front garage wall which is consistent with pressure release due to movement of the garage peninsula.

R – Sufficient movement indicators were observed and present to request that the design engineer pay a visit to access the foundation's performance, provide an opinion on future performance and make a 'base' elevation study. The study and a performance letter should be provided to the buyer. Assuming that the design engineer indicates a positive result or if the builder declines to request the engineer, I recommend that a structural engineer should be consulted pertaining to stabilization measures for this foundation.

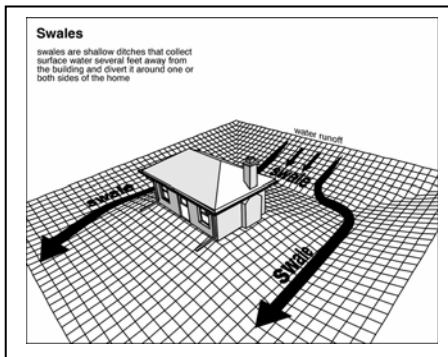
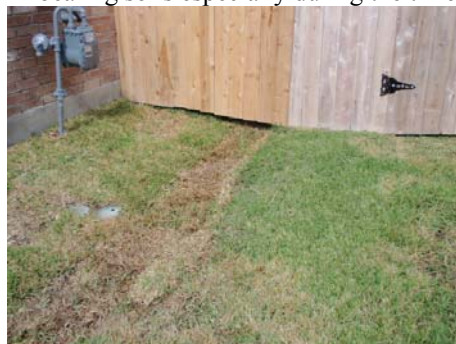
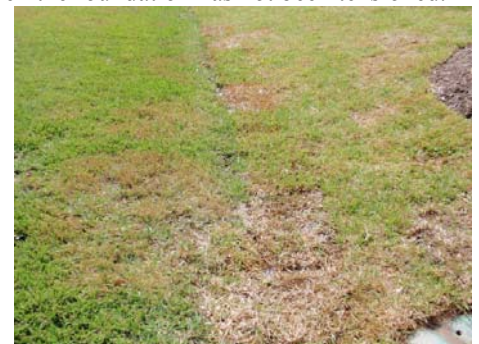
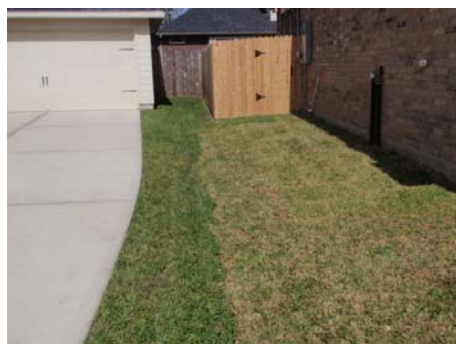
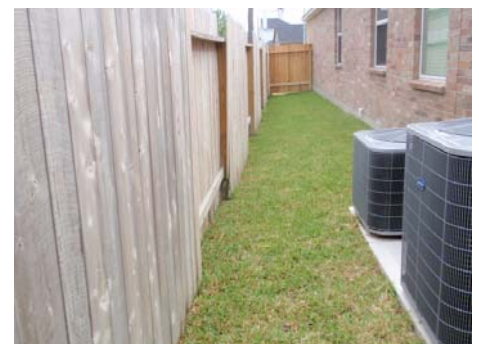
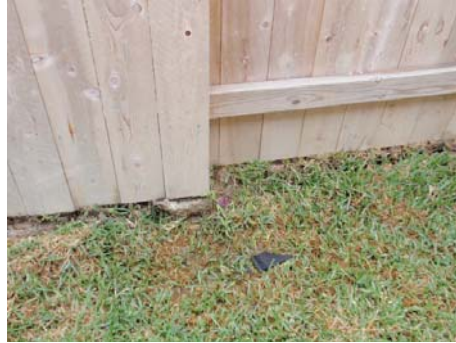
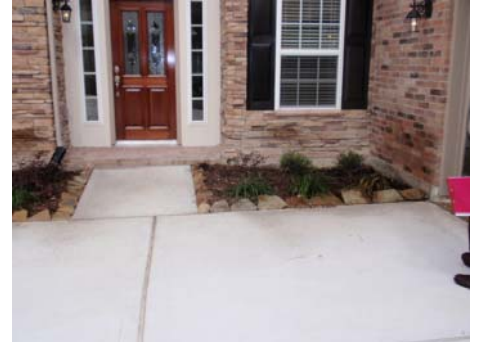
- A low area is present off the left rear corner
- A low area is present off the right front corner
- The swales are not operational from the rear to the front
- Both side swales are installed wrong on the property lines. As in previous reporting, the home to the right drains onto this property
- Grading for the left side has been established and drains onto the adjacent property The bed, to the right of the front entry, is low and does not drain

The rationale for highlighting the grading at this juncture is the youth of the foundation (not completely cured) and the impact that the poor drainage has on the bearing soils especially during the time when the foundation has not been tensioned.

R - The grading should be improved to promote the flow of storm water away from the house and off the lot. The ground should slope away from the house at a rate of one inch per foot for at least the first ten feet. Ideally, at least eight (8) inches of clearance should be maintained between soil level and the top of the foundation walls. See comments/recommendations under foundations. Trenching, against the foundation, is not acceptable.

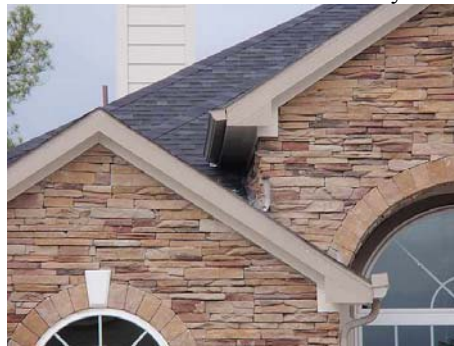
R – A debris catching area, known as a trap, is present on this roof design between the front entry and dining roof valley. Roofing will deteriorate more quickly at this location due to the built up of debris. The debris should be kept cleared in this location. Due to this debris, water dams can back up water causing leak issues. A ½ cricket should be installed in this area to terminate the valley beyond the corner of the brick. This type of shingle is not intended to run ‘flat’ nor is the metal (long the wall), it must have a 3 in 12 pitch to prevent water penetration. 903.4 Roof drainage.

Additionally when synthetic stone is used, as on the left exterior wall of the entry, the protocol for flashing installation is the same as for stucco. The vertical flashing must be placed behind the synthetic stone and behind the moisture barrier of the synthetic stone.

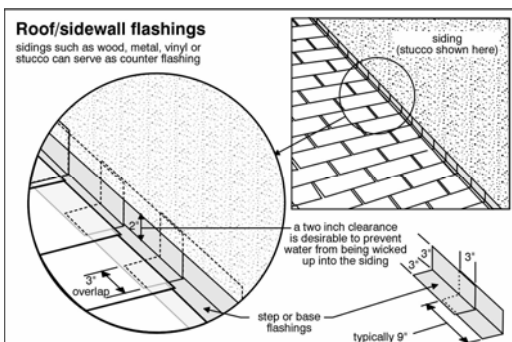
R – At locations where sloped roof shingles meet sided or masonry walls, step flashing should be installed here rather than J type flashing. You should know that siding and shingle companies are moving to void the warranties of their products if “step” flashing is not used:

IRC 905.2.8.4 Sidewall flashing.

Flashing against a vertical sidewall shall be by the step-flashing method.

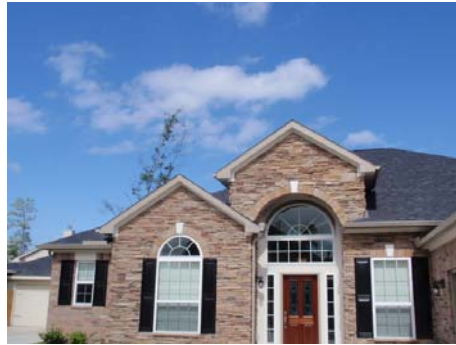
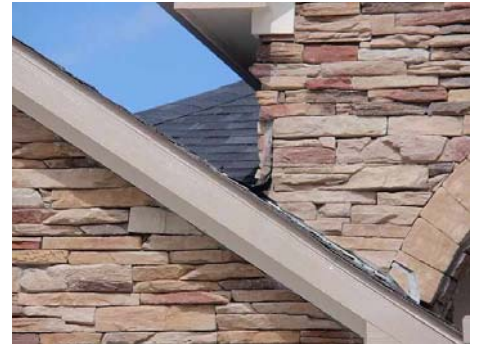
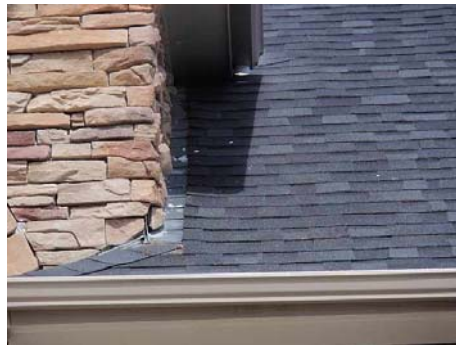
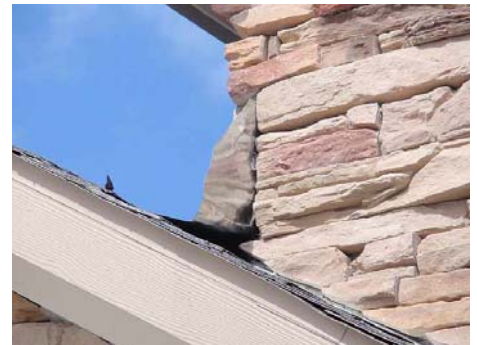
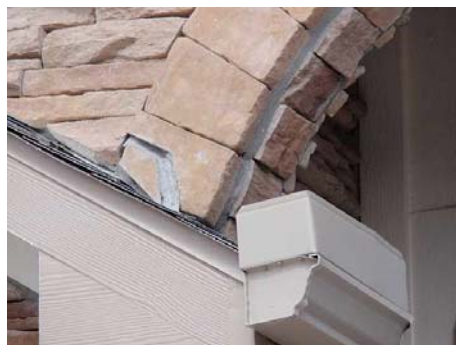
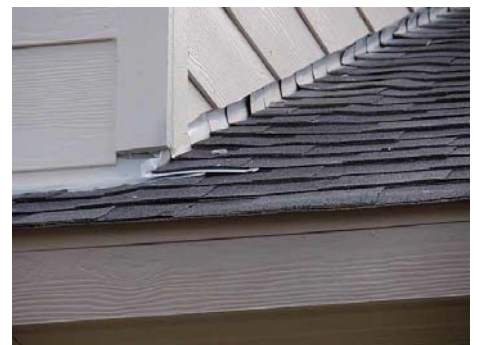
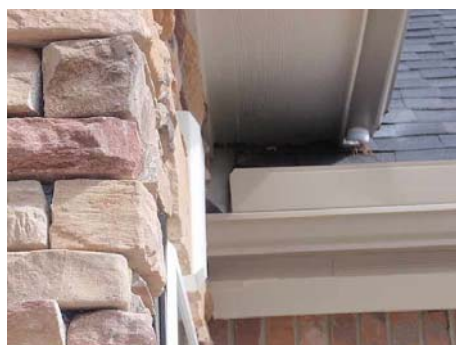
- The east game room wall does not have step flashing
- The west game room wall has both step and J flashing, the J should not be there
- The shingles should ‘ride’ over the flashing allow 1 inch of flashing to show otherwise leakage can occur – this applies to all violating areas
- The east entry wall has both step and J flashing, the J should not be there
- The west entry wall – the flashing for the wall, parallel to the street, should extend straight thru towards the porch

Comment – the flashing at the left side of the entry is very poor workmanship.

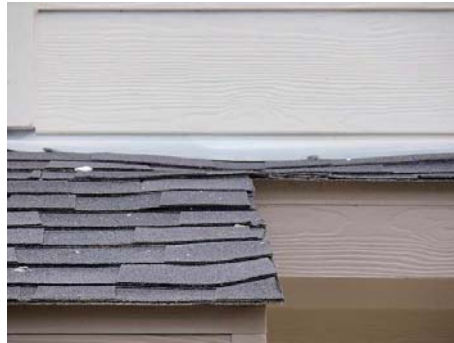
R – There is unsupported decking below the left side of the game room at the rear of the home.

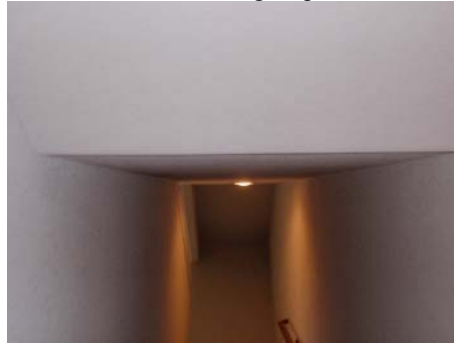
R – The stairs ceiling slopes downward to the west wall.

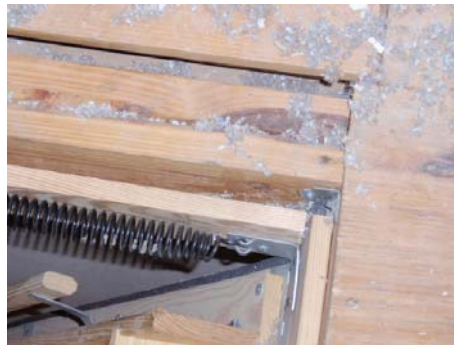
R - The attic stair frame needs to be blocked to the joist framing. It is currently secured with insufficient and/or unblocked fasteners. The fastening devise should penetrate the stair frame, the block and the attic framing. This penetration should occur five times on each long side and three times on the two short sides of the attic stairs. Some of these fasteners should penetrate the hinge plates and pivot s. Typical recommended manufacturer fasteners include 16d nails or 1/4" x 3" lag screws.

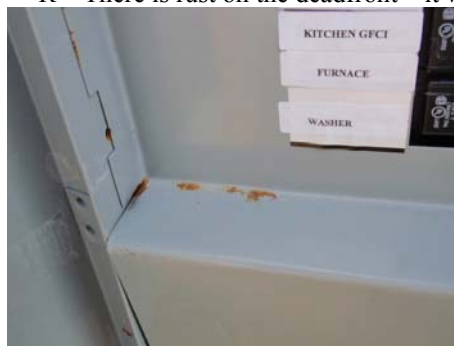
R – There is rust on the deadfront – it will continue to oxidize.

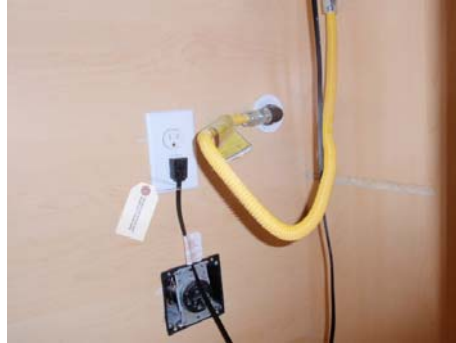
R - Missing outlet cover plates should be replaced. Under range.

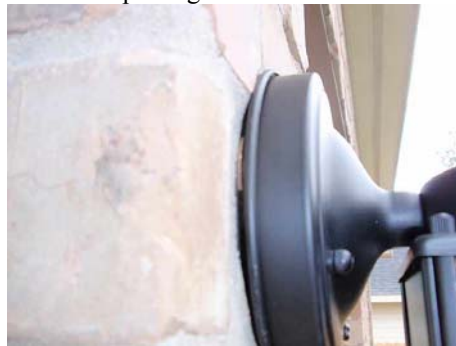
R – The exterior lights have been caulked to the veneers but are missing a weatherproof gasket.

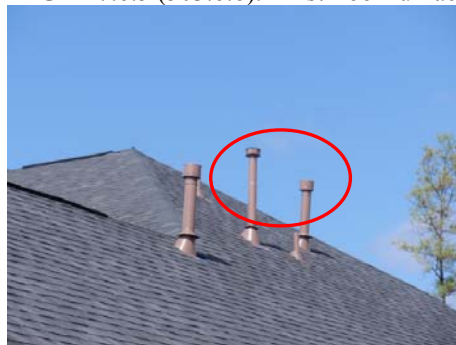
R – The gas vented appliance flues should extend 2 feet above the roof covering and 2 feet above the closest horizontal 10 foot roof area, for drafting reasons – IRC G2427.6.5 (503.6.6). First floor furnace flue.

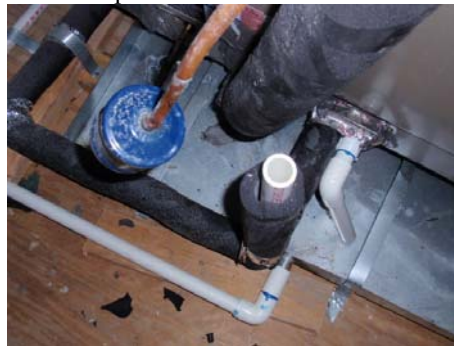
R – A clean-out pipe extends upward on the a/c condensate lines to facilitate flushing of the line in case of clogging – they is expelling air conditioned air into the attic which is inefficient – they should have a “trap” in the condensate line between it and the evaporator coils.

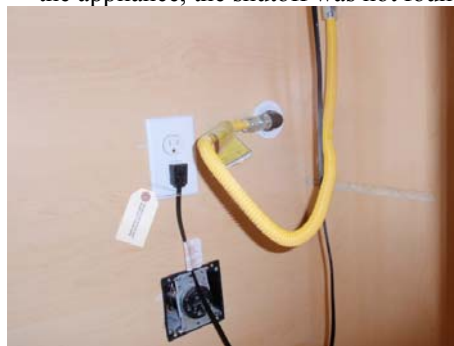
R – All gas fired appliances are required to have a gas shutoff valve within 3 feet of the appliance, the shutoff was not found for the oven or range.
