PROPERTY INSPECTION REPORT

Prepared For: Andy
(Name of Client)

Concerning: 13706 in the community of Sycamore Valley
(Address or Other Identification of Inspected Property)

By: Michael Cothran, TREC License # 2995 2/13/2009
(Name and License Number of Inspector) (Date)

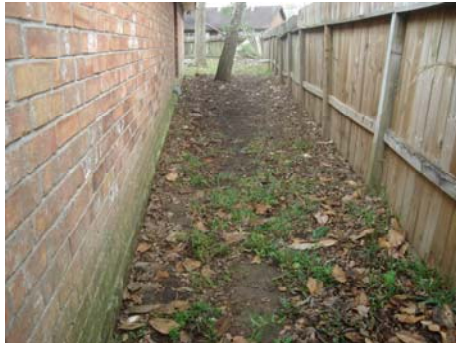
R - The grading should be improved to promote the flow of storm water away from the house and off the lot. The ground should slope away from the house at a rate of one inch per foot for at least the first ten feet. Ideally, at least eight (8) inches of clearance should be maintained between soil level and the top of the foundation walls. See comments/recommendations under foundations.

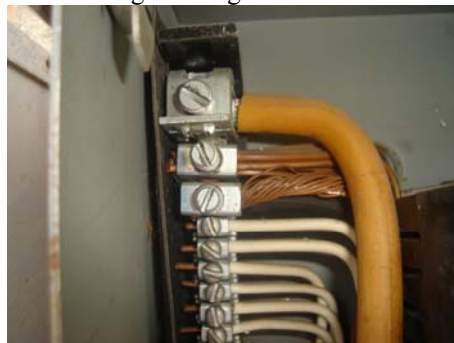
R – The grounding wires should be in separate connectors at the bus bar.

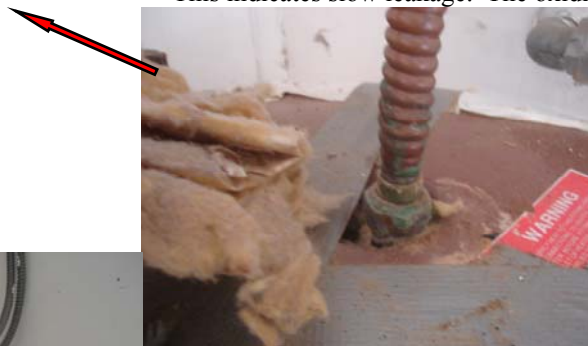
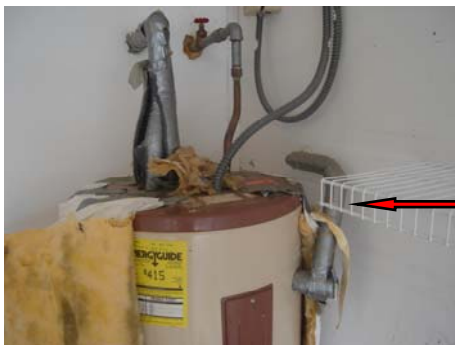
R - The supply piping shows evidence of corrosion where it meets the water heater. This indicates slow leakage. The oxidized unions should be replaced. Cold feed.
